TWA Flight 800 Missile Impact Analysis

by
Richard Bott
Survivability Division
Systems Engineering Department

DECEMBER 1997

NAWCWPNS TM 8126

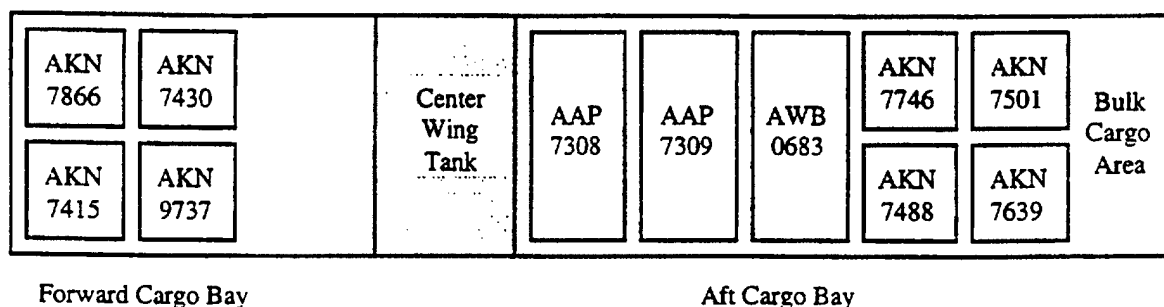
FIGURE 1. Cargo Container Locations on TWA Flight 800.

Four baggage containers were located in the forward cargo compartment of TWA Flight 800. A diagram of all container locations is shown in Figure 1. The two containers on the left side of the aircraft, AKN7415 and AKN9737, were recovered in the red debris field and were not severely damaged. Both containers have virtually all sides intact, and the damage is consistent with water impact.

The two containers on the right side of the forward cargo hold, AKN7866 and AKN7430, were recovered in the yellow debris field. These containers are more severely damaged, but the majority have been recovered and reconstructed. The damage also appears to be attributable to water impact.

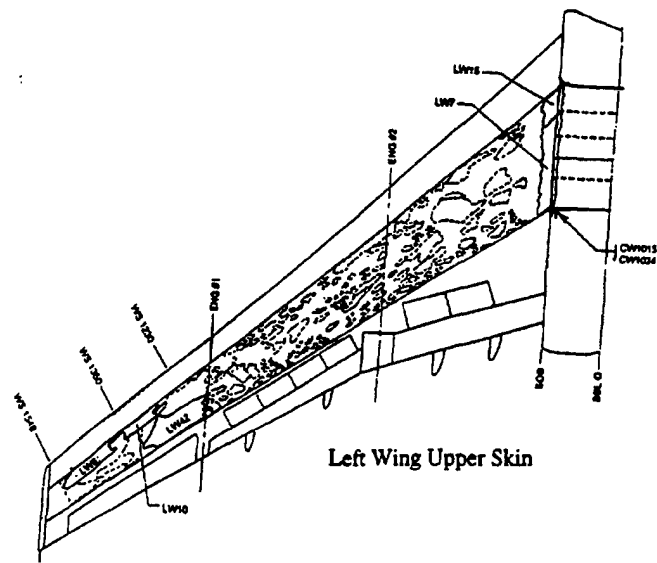
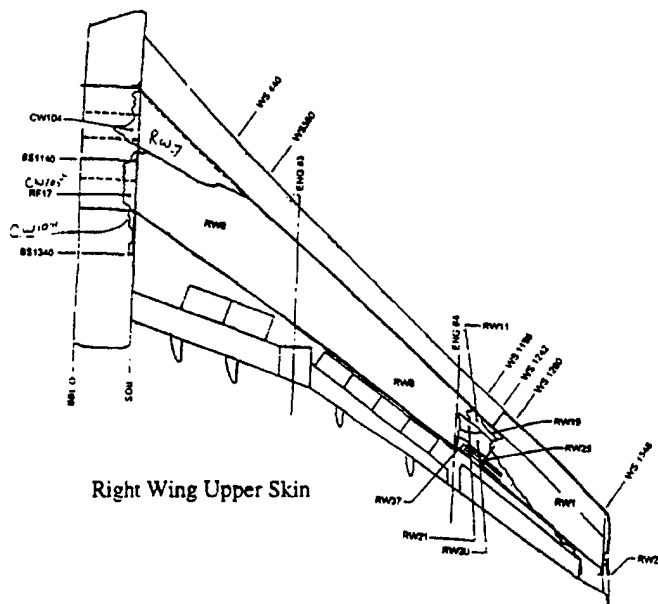
FIGURE 3. TWA Flight 800 Upper Wing Skin Damage.

Detailed examinations of the TWA Flight 800 wing fuel tanks were conducted. The left upper wing skin, the left side-of-body rib, and the left leading-edge spar exhibit different and more severe damage from their right wing counterparts. Figures 3, 4, and 5 show comparisons of the damage to the upper wing skins, side-of-body ribs, and inboard leading-edge spars, respectively. Close inspections of the wreckage in these areas revealed no evidence of penetrations by foreign objects and no high-velocity fragment damage consistent with a missile impact. NTSB and FBI documentation support these findings (References 3 and 4).

Some unexplained damage characteristics on these structures have puzzled investigators, for example, the severe shattering of the left wing upper skin. While the damage mechanisms involved may not be completely understood, the recovery and reconstruction of TWA Flight 800 is the most comprehensive undertaking of its type ever made. This wing damage may be typical for severe water impacts but has gone unnoticed in previous mishaps due to the lack of recovery and reconstruction of debris. Further, the left and right wings of TWA Flight 800 impacted the water in different attitudes, as evidenced by the damage to the engines, which may explain the disparity in damage between the two structures. These damage characteristics are not deemed characteristic of a missile impact. but without validating test data this conclusion cannot be made with 100% certainty.

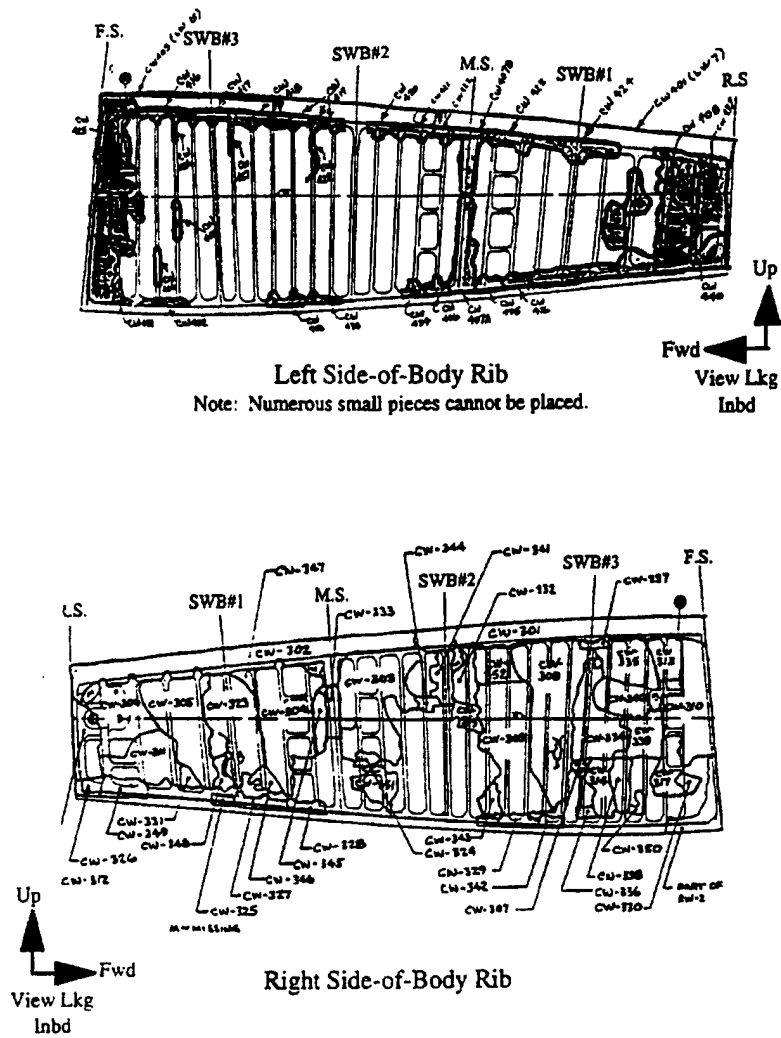
FIGURE 4. TWA Flight 800 Side-of-Body Rib Damage.

Conceivably, a missile impact in the wing-root fuel tank area could create enough damage to cause the side-of-body rib to collapse into the center wing tank. This collapse could occur without significant release of material from the wing structure, but the preponderance of evidence suggests this did not occur on TWA Flight 800. Most compelling is the fact that both wings remained with the aft fuselage section until they were well downrange. If the severe left wing damage had been caused by a missile impact, the expected result would be an early release of that wing, or at least numerous pieces of it, well uprange in the red recovery zone.
